Investigation of Cold Cathodes
for
Long Life CO₂ Waveguide Lasers

Annual Summary Report
for Contract N00014-79-C0312

U. Hochuli

November 1981

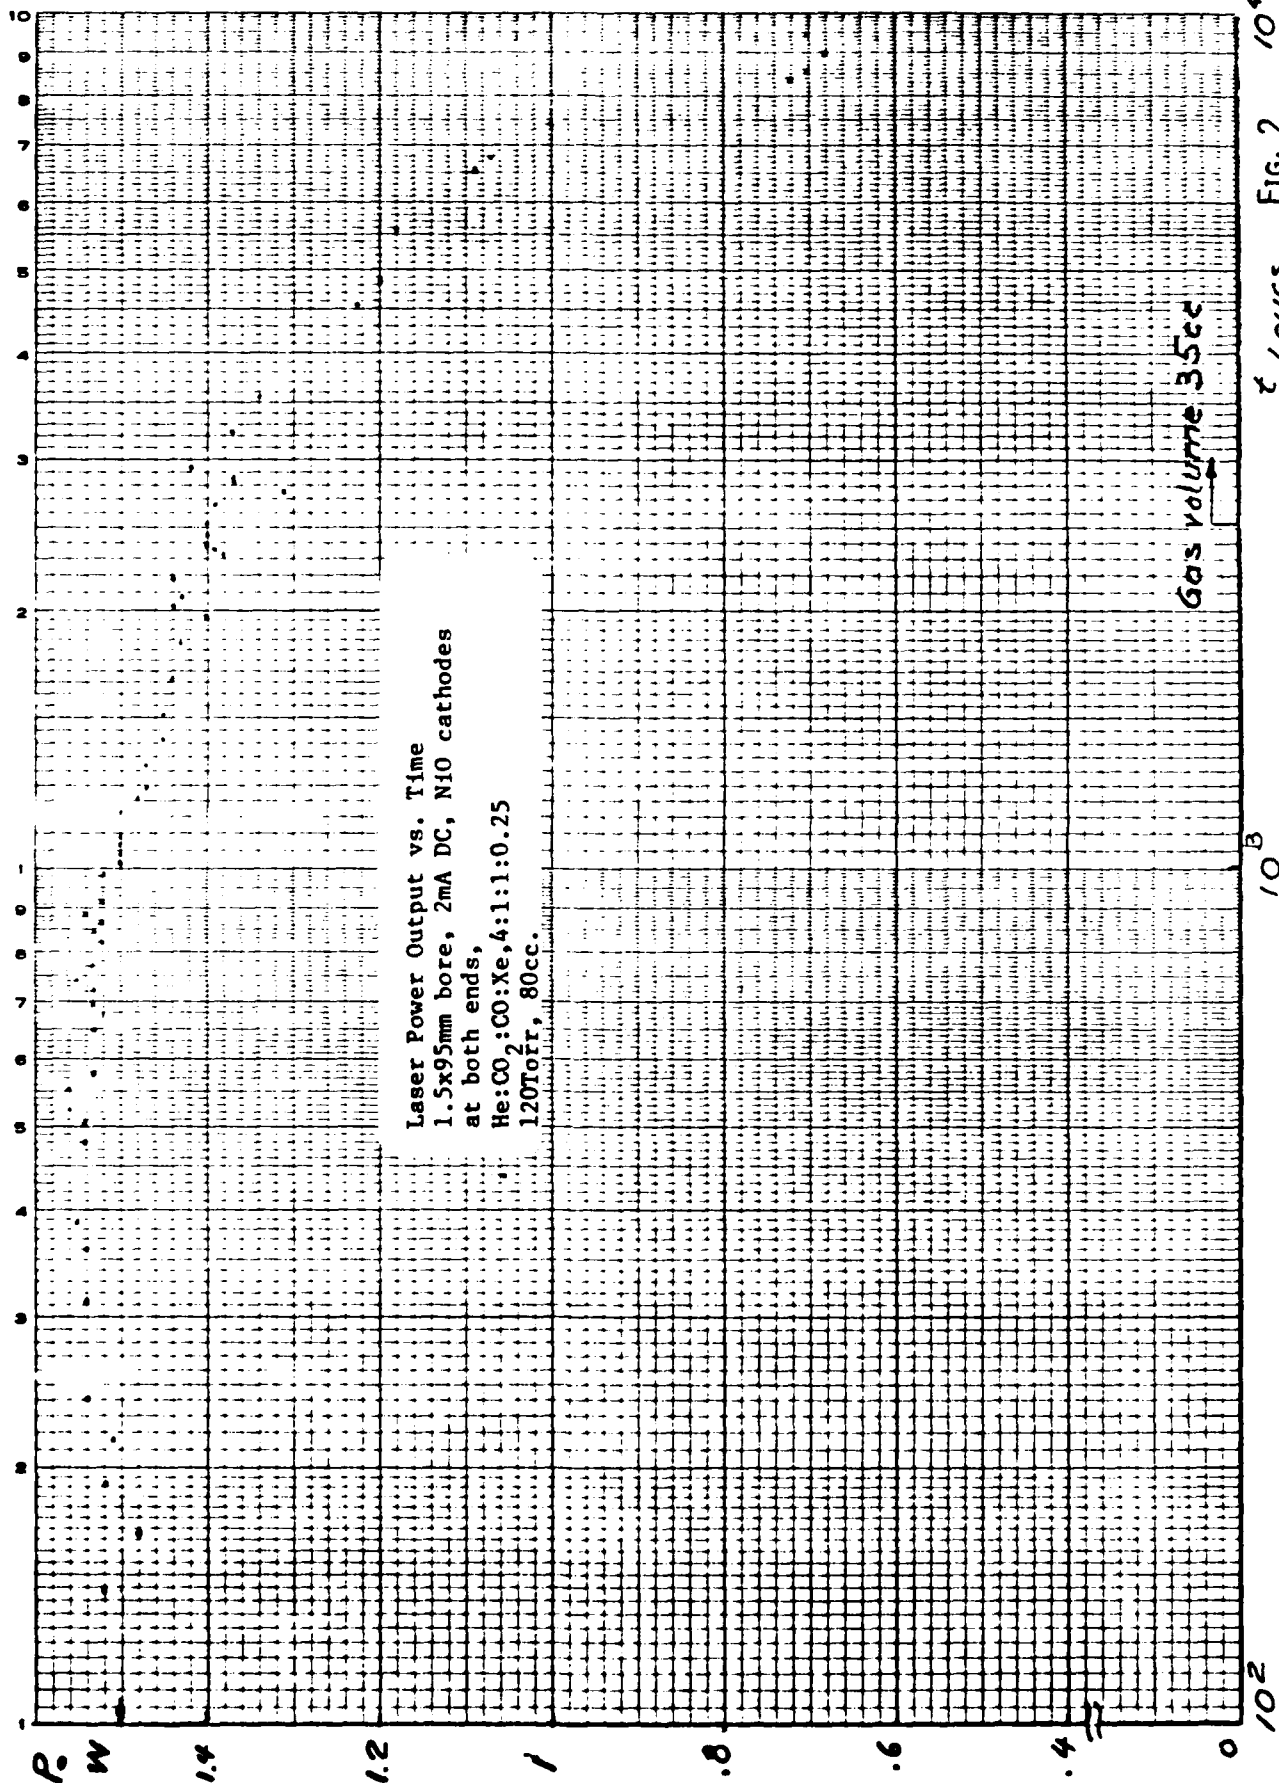
FIG. 2

As Figure 2 shows the power output of this laser decreased from 1.54W to 0.7W after 9500 hours. Evacuation to 1 Torr and refilling restored the power to only 0.86W. Vacuum pumping and 100°C heating for two days, followed by refilling, restored the output power to 0.9W. Our laser structures use external windows (uncoated ZnSe, tilted 7° to avoid retroreflections) as vacuum seals behind the internal mirrors. Power supply failure over one weekend lowered the laser body temperature to the 15°C cooling water temperature.

Humidity had condensed on these windows and together with the dust and the grime formed water spots. A cotton swab and alcohol treatment could not remove these spots. At the time we thought that this visual degradation would not absorb much power at 10.6μ . Repolishing these windows, on the laser, with Linde type A and B Al_2O_3 polishing compound improved the laser power output to 1.34W. Replacement of two additional mirrors (front surface Al coated, used for deflection of power from both laser ends onto power meter) further increased the power meter reading to 1.4W. This value is within 10% of the original 1.54W and is an indication that no serious mirror damage had occurred. Removal of the laser mirrors revealed the central 1.5mm area either by breathing on it or by noticing a very faint greenish hue through observation of the surface at a glancing angle. Very few specks of black NiO with diameters of 10 to 30 microns could be seen in the BeO cathode cavities. The Al_2O_3 sputter shields also had a light black color in the central hole and the color gradually thinned out into a very light greenish hue over most of its front surface. This greenish hue did not seem to extend into the cathode cavity of the BeO body.

Auger spectroscopic analysis, performed by the National Security Agency, showed about equal peaks of Ni and C plus an excess of O for the cathode sputtershield deposits and a carbon layer on the mirror spots. One mirror spot had a $50A^\circ$ thick carbon layer while the other mirror spot had a much thinner layer which may have been the result of CO_2 adsorption.

No trace of chlorine was found on either mirror. These results are strange because for a laser which is symmetrical with respect to both mirrors we expect similar results for both mirrors. Optically we did indeed see similar spots of faint discoloration for both mirrors. We believe that the heavier, or even both carbon deposits resulted during the gas refilling operation that took place after 9500 hours. We refilled the laser slowly but even then we may have stirred up carbon deposits in the bore and swept them to the mirrors. Since the gas inlet port was asymmetrically located behind one of the cathodes it could explain the different thicknesses of the mirror deposits. Later, this carbon dust may have absorbed enough laser power to bake on to the mirror surface. So far we do not think that we have a good explanation for the optically visible mirror spots and we may have to analyze these areas again. It may also turn out that Auger surface analysis can not explain these discolorations which may be the result of UV exposure. We have in the past observed permanent color changes of dielectrically coated ZnSe mirrors as a result of simple heating to perhaps 200 to 300°C in air.

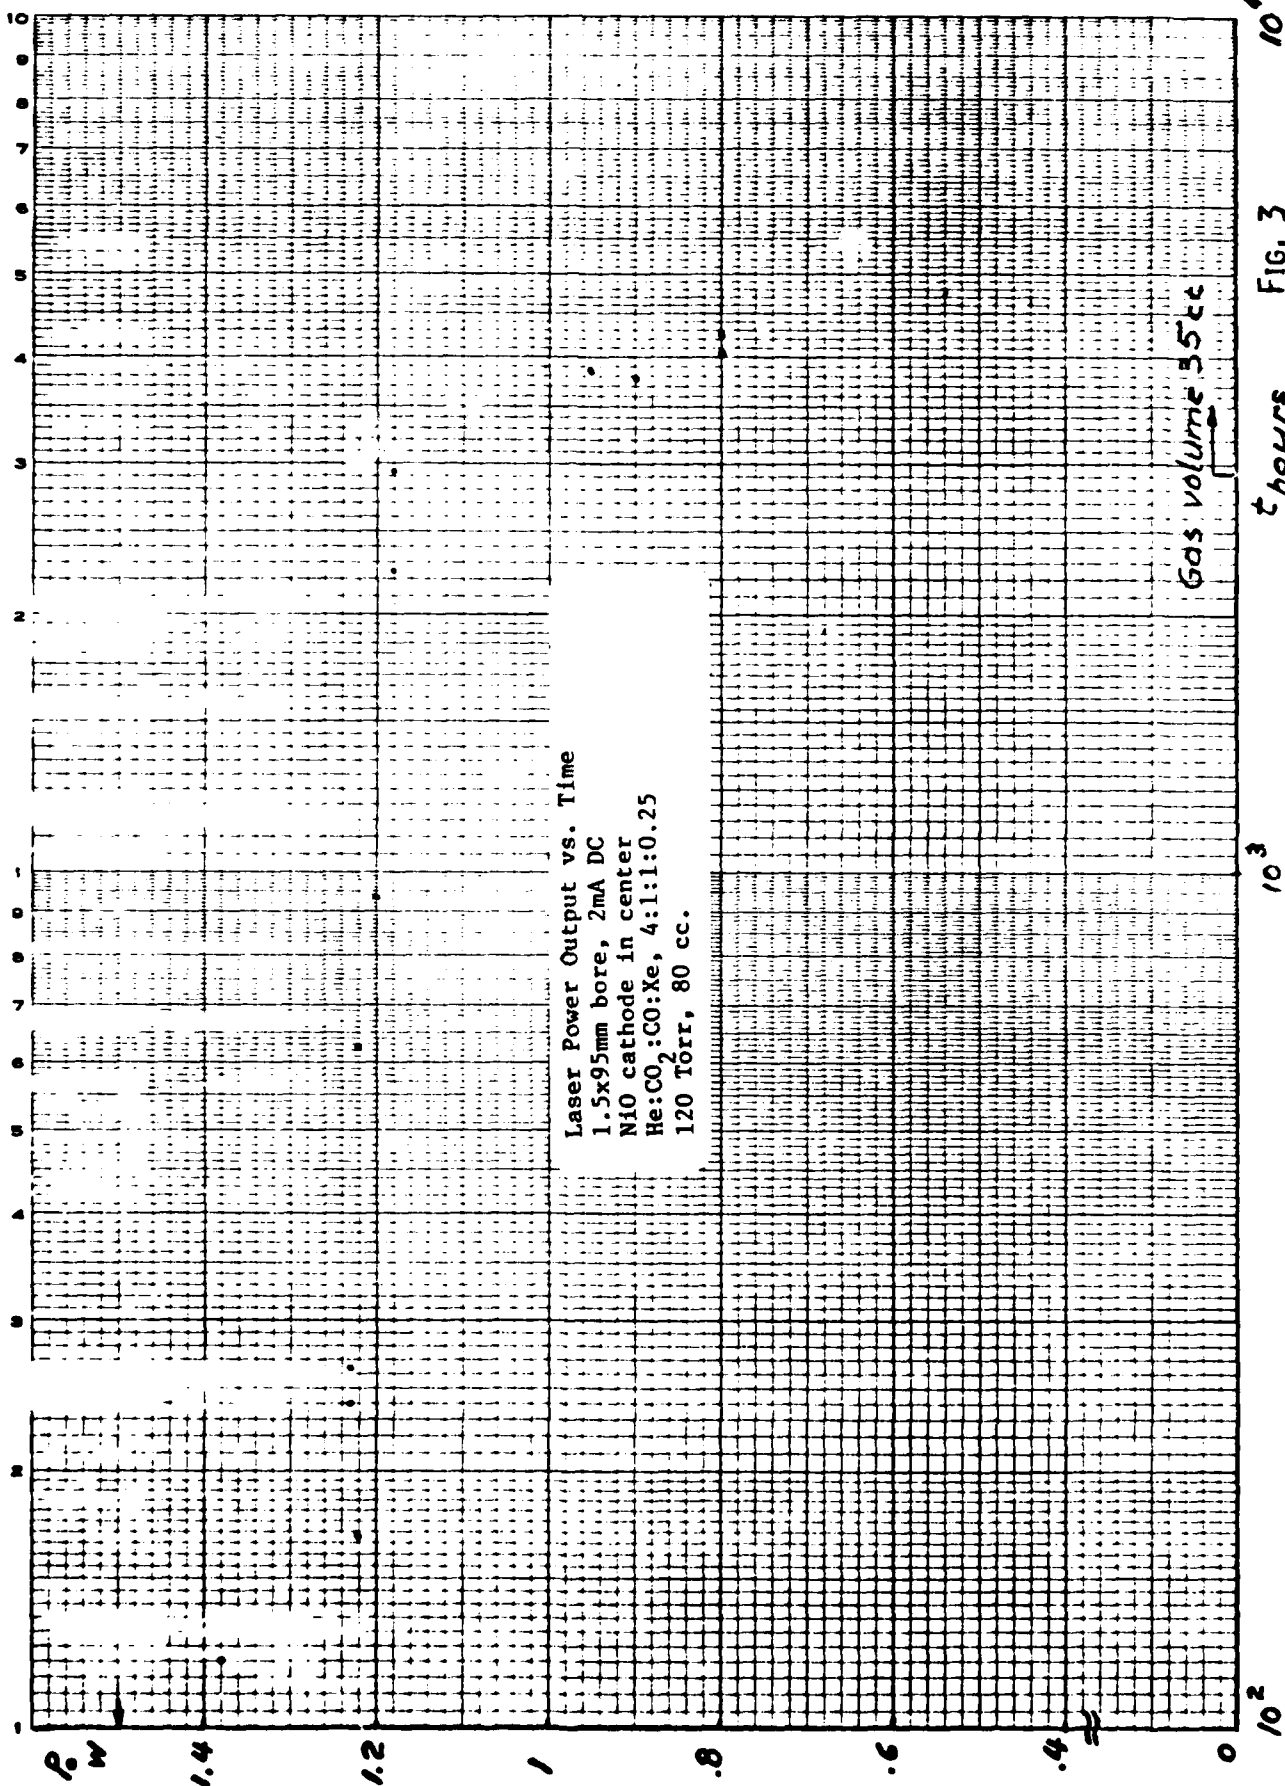
FIG. 3 10³ 10⁴

Figure 3 indicates a power drop from an initial 1.5W to 0.54W after 4750 hours. Increasing the gas volume again to 80cc, by reconnecting the laser to the same gas supply

that was used for the first 2900 hours, raised the output power to 1.2W. Pumping down to 1 Torr and refilling the laser with new gas increased its power output to 1.4W compared to 1.5W for the new laser. This indicates that no serious mirror damage had occurred. The laser was then carefully evacuated with the Vac-Ion pump and outgassed for two days at 100°C. Refilling and measuring the power output gave 1.39W or essentially the same as before. 1300 hours later this output was down to 0.68W, almost as before. Leak testing revealed a small leak through the once repaired crack in the BeO structure. This leak was most likely caused by the previous 100°C heating cycle.

Opening the structure revealed a crater like, metallic looking, material build-up around the center hole in the cathode sputter shield. This deposit turned out to be Ni originating from the sputtered, reduced NiO of the cathode. The cathode cavity in the BeO body contained about 20 flakes in sizes ranging from 10 to 50 microns in diameter. About half of them appeared metallic and were magnetic and the rest looked like black NiO. X-ray fluorescence analysis confirmed Ni as the dominant composition of the flakes.

Inspection of the mirrors under a microscope revealed no surface degradation. Breathing on the mirrors enabled us to distinguish the central area opposite to the 1.5mm bore. X-ray fluorescence analysis also distinguished this area but did not reveal a different composition from the rest of the

mirror. Auger spectroscopy, performed at the Naval Research Laboratory, showed an excess of chlorine and oxygen in the central mirror area. The excess oxygen most likely resulted from either the pure oxygen discharge used to clean the laser before the actual filling took place or from the exposure to the laser discharge that always contains oxygen from dissociated CO_2 . However, the presence of chlorine is more difficult to explain. One possible chlorine source may be the indium "O" rings. These "O" rings were cleaned in 50% HCl followed by ultrasonic cleaning in distilled H_2O and alcohol. Any formation of InCl , InCl_2 and InCl_3 should easily be dissolved in H_2O and washed away. Other chlorine sources may be: the 0.0005% Cl present in the nickelous nitrate used as the basis material for our NiO cathodes and/or chlorine presence in the 5% binder used in the Al_2O_3 sputtershield ceramic.
